## Journal of Advanced Research in Business and Management Studies

# Improving Customer Satisfaction and Packaging Quality in Sunscreen Products: A Case Study on Failure Analysis and Design Improvement

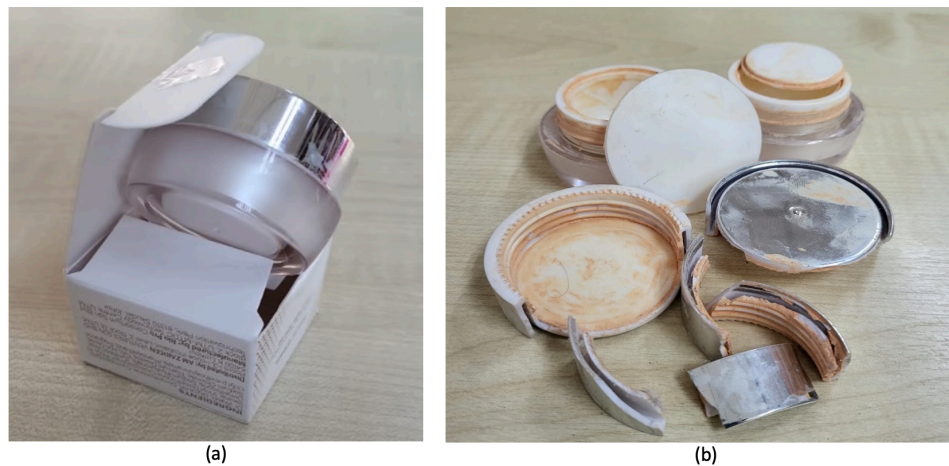
All conditions of the sunscreen packaging, both before and after breakage, are shown in Figure 6. Due to strong customer complaints regarding the lid's fragility, the beauty brand is now seeking to improve the quality of its packaging design. Additionally, incorporating sustainable packaging materials is seen as a positive step toward aligning the product with the company's Sustainable Development Goals (SDGs) and enhancing future design improvements.

**Fig. 6.** Sunscreen product shown in (a) new and intact condition, and (b) various severe breakage conditions, particularly highlighting damage to the cap of the bottle

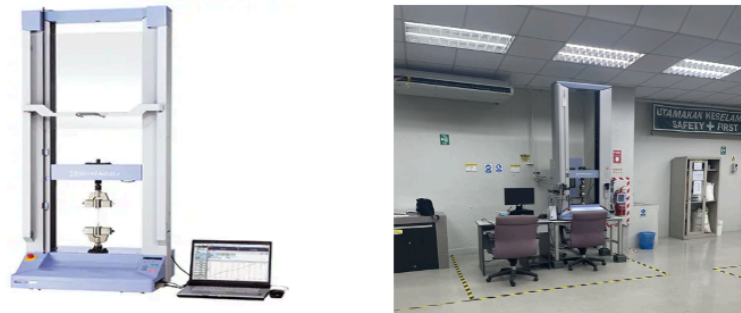
After identifying the packaging failure problems, experimental testing was conducted using the Universal Testing Machine (Shimadzu) at Universiti Teknologi Malaysia, Kuala Lumpur, where compression tests on sunscreen lids were performed with a force of 18,000 N. In this experiment, the stress-strain graph will be obtained specifically utilizing the Shimadzu model for initial compression testing, as shown in Figure 8. The Universal Testing Machine is a versatile mechanical

**Fig. 8.** Universal Testing Machine by Shimadzu at laboratory of Universiti Teknologi Malaysia, Kuala Lumpur

The Universal Testing Machine above features automatic reading of load cell characteristics, with real-time displays for test force, stress, stroke, and position. It also includes an external analog output with two channels. The digital display offers a resolution of 0.001 mm. Key specifications of the equipment used for dataset development are in Table 1.

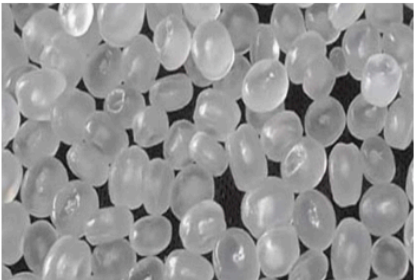
Data from these tests were used as inputs for simulation predictions via Ansys software, aiming to replicate failure behavior observed experimentally and validate simulation benchmarks. Simulation is incorporating the characteristics of polypropylene (PP) as shown in Figure 9.

**Fig. 9.** Polypropylene and its material properties [7]

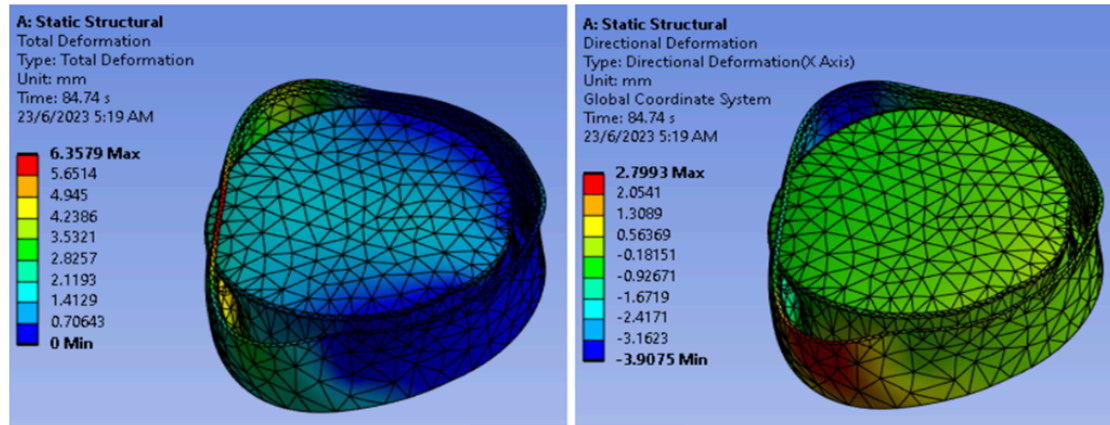
**Fig. 12.** The simulated displacement distribution on the sunscreen

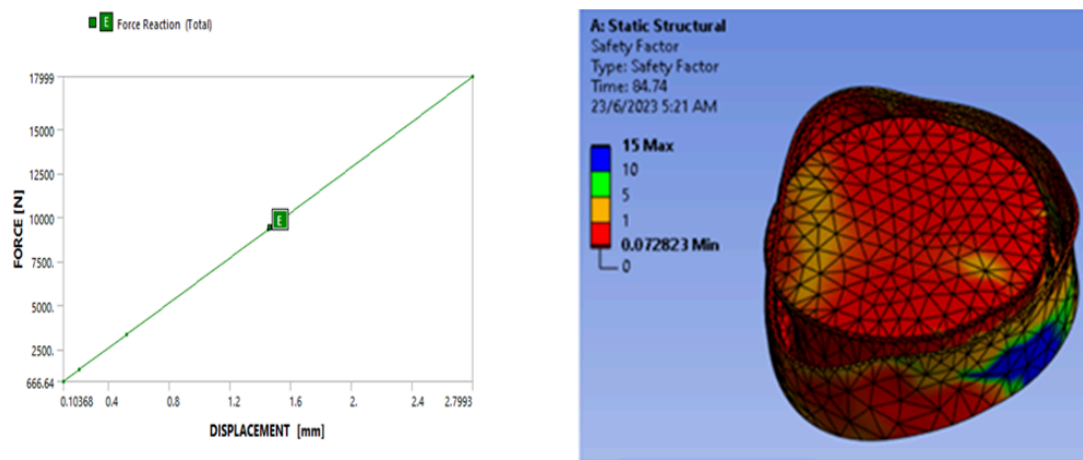
Critically, safety factor values around the lid area fell below 1, as shown in Figure 13, indicating a high risk of structural failure in this region. This aligns with simulation outcomes, which predicted failure in the outer lid. Notably, from experimental testing validated the simulation results, as illustrated in Figure 14. Both tests exhibited an identical "butterfly" failure pattern, supporting the conclusion that the material lacks sufficient ductility.

**Fig. 13.** Stress-strain curve and corresponding factor of safety (FOS) from simulation

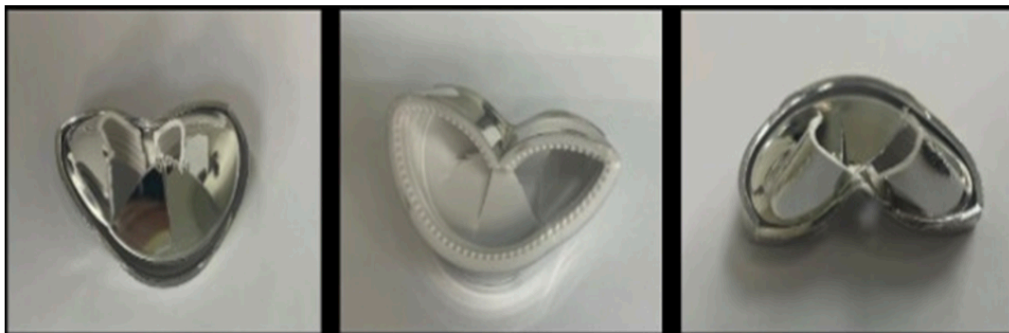
**Fig. 14.** The experiment testing results using universal testing machine

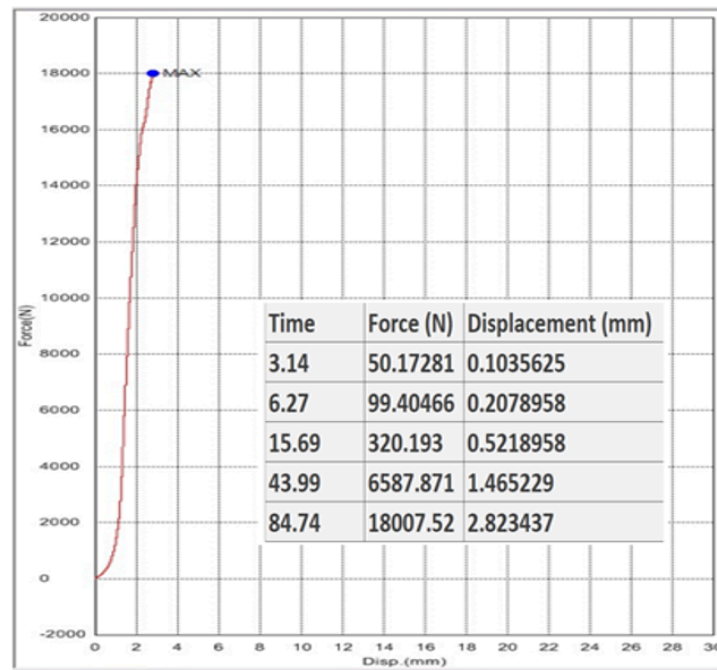
Figure 15 confirms the material's brittle nature, reinforcing that it is unsuitable for components subject to sudden or repeated mechanical loads. The lack of energy absorption capacity is a fundamental limitation, and in this case, was identified as the root cause of packaging failure in the sunscreen product manufactured by the beauty company.

**Fig. 15.** Experimental stress-strain curve obtained using the universal testing machine

The root cause of the sunscreen packaging failure was effectively identified through a combination of simulation and experimental analysis. Simulation results demonstrated that the Von Mises strain closely matched the maximum principal elastic strain, indicating localized material failure in the outer cap. This was further supported by low factor of safety values observed across the lid, confirming its inability to withstand the applied loads. Experimental testing, conducted using a Universal Testing Machine, verified that the cap material failed in a brittle manner. These tests revealed that the aluminium cap functioned primarily as a decorative element, offering minimal structural support. The strong alignment between simulation and experimental findings validates the diagnosis and confirms that the brittle nature of the cap material was the primary cause of leakage and mechanical failure. This study emphasizes the critical importance of accounting for brittleness during material selection, as brittle materials typically lack the ability to absorb impact or dissipate energy, making them unsuitable for components subjected to sudden or repeated stress. It also highlights the necessity of anticipating potential failure modes and incorporating adequate safety margins in the design phase to ensure reliability and long-term performance.

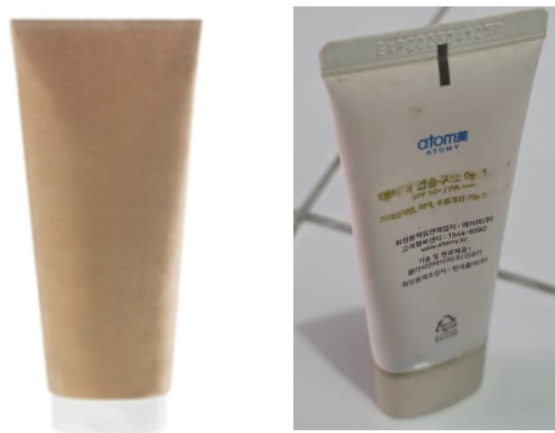
In response to customer feedback emphasizing sustainability, a shift toward more environmentally friendly packaging has been initiated. Alongside improved sustainability, the redesigned packaging is expected to offer better durability and quality, as depicted in Figure 16.

**Fig. 16.** Proposed tube-format packaging design for the new sunscreen product

To ensure the new sunscreen cover meets performance requirements, materials with low brittleness and low light transmittance are necessary. Based on a comprehensive literature review, Polyethylene Terephthalate (PET) is recommended as a suitable alternative. PET offers several benefits for this application, including high strength, light weight, excellent shatter resistance, and low gas permeability. Additionally, it exhibits low light transmittance, with polypropylene demonstrating complete UV absorption between 200 nm and 310 nm, as noted by Müller et al. (2023) [4]. The new design features a compact, waterproof tube format that maintains the original 10 ml volume, unchanged as capacity was not an issue. Aesthetically, light-colored packaging is preferred

The simulation clearly exposed structural vulnerabilities in the cap design, reinforcing the need for enhanced material selection and improved engineering. Based on a thorough literature review, Polyethylene Terephthalate (PET) is recommended as a more suitable material. PET offers key advantages for this application, including high strength, lightweight properties, excellent shatter resistance, and low gas permeability. Beyond the technical insights, the investigation uncovered broader systemic issues such as poor material traceability and insufficient oversight in procurement and production processes. To address these challenges, the study recommends sourcing verified materials, redesigning the cap for improved durability, and adopting a more customer-focused approach to packaging development. Ultimately, this case highlights the essential role of packaging integrity that not only in preventing product failure, but also in maintaining brand trust, enhancing customer satisfaction, and supporting operational efficiency in an increasingly competitive market.
